Final Removal Action Report

Mansfield Trail Dump Site
Stanhope-Sparta Rd
Byram Township, Sussex County, New Jersey

Removal Support Team 2
Weston Solutions, Inc.
Northeast Division
Edison, New Jersey

January 2013

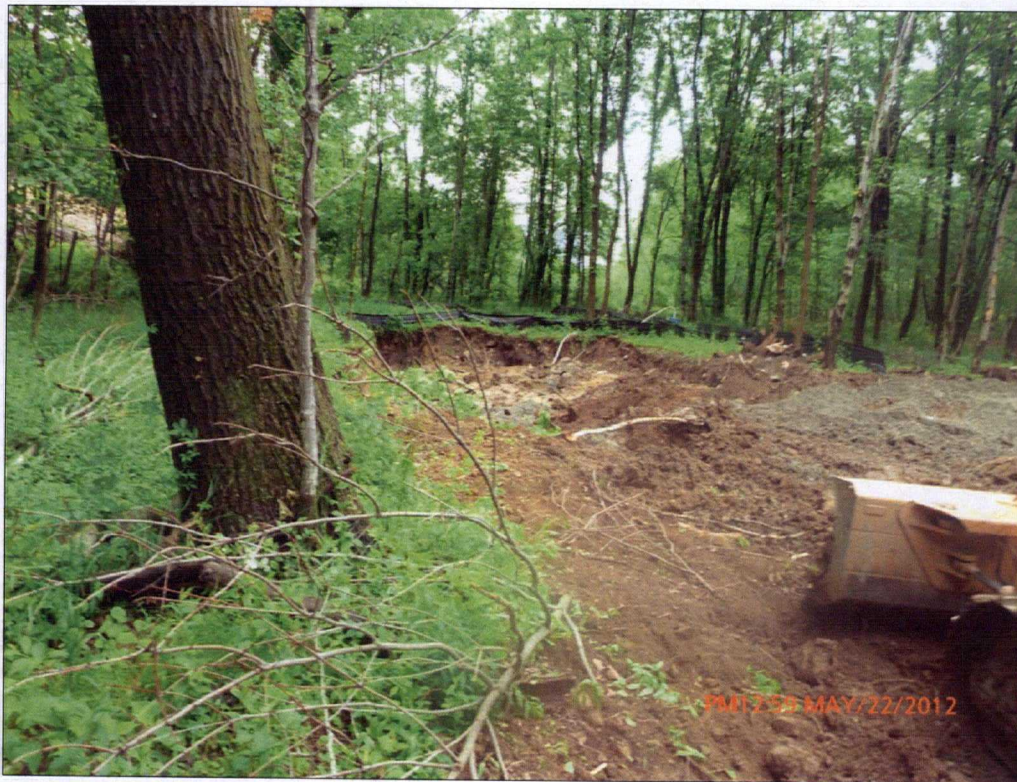
Photograph 10: A view of Dump Area E backfilling, taken on 05/22/12 at 1247 hrs.

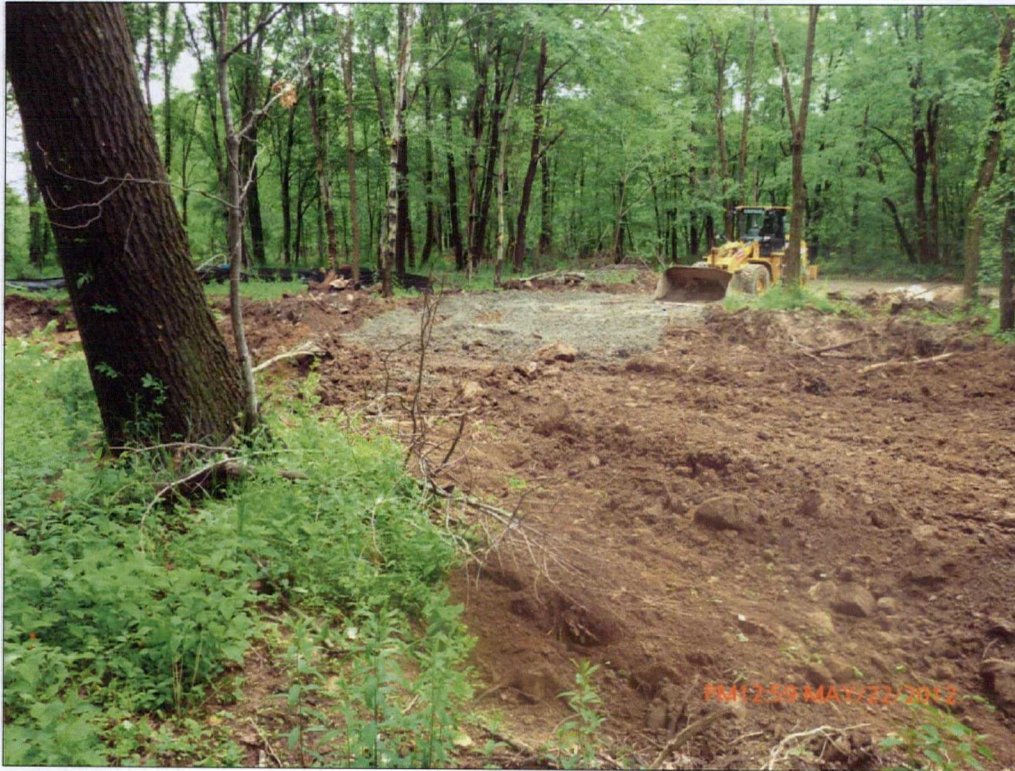
Photograph 11: A view of Dump Area E, backfilling and grading, taken on 5/22/12 at 1259 hrs.

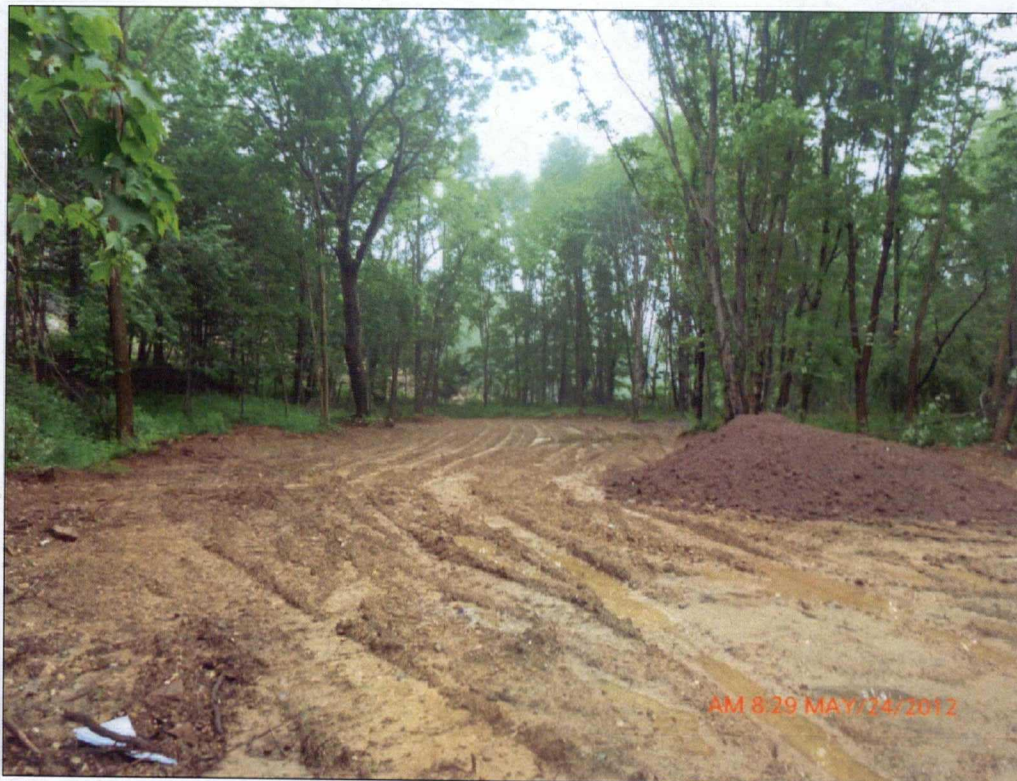
Photograph 12: A view of Dump Area E after completed removal activities, taken on 5/24/12 at 0829 hrs.

Dump Area E: Due to very wet soil conditions from rain events following excavation activities, clean soil was used to stabilize soils for grading. Hydroseeding was completed in this area for erosion prevention.
